INVENTORY FORM FOR STATE HISTORIC SITES SURVEY

Top Mark Farm

Jamaica Point Road (Barber Road)

Trappe

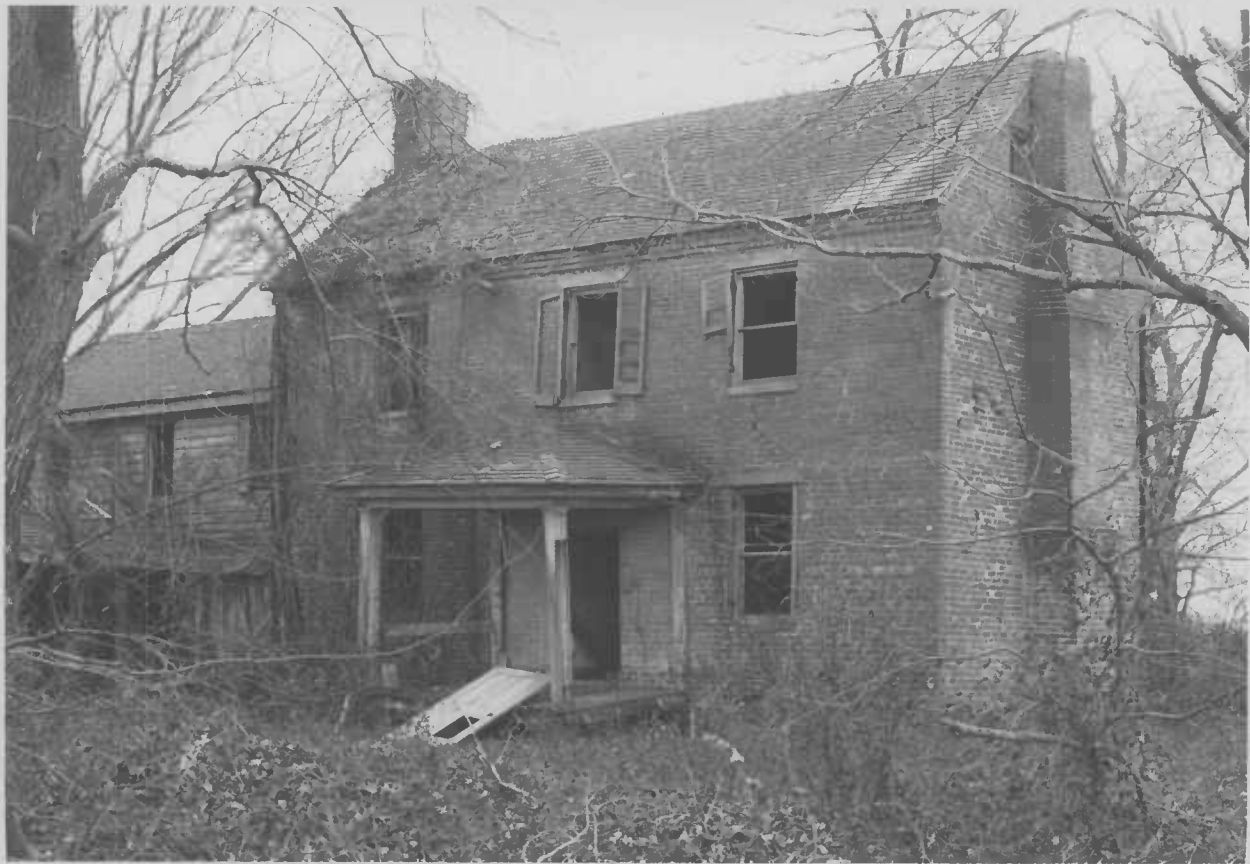
T- 134

Top Mark Farm was an interesting structure prior to its being allowed to fall into ruin. It is composed of a two story brick part with a two story frame part. Behind (north) of the latter part is a one story hyphen and another two story section. The frame sections of the building appear to have been constructed around the turn of this century.

On closer examination it was found that the brickwork on the front and back of the house is different above the second floor level. On the gables the outline of a gambrel roof is discernible. On the inside the west wall has several broken bricks visible where the original interior chimney was removed to make the room larger during the major remodeling.
